# NOTES & OBSERVATIONS

**CLIENT:** Walter Sedovic Architects    **Work Order** 1559    **DATE:** 12/28/21  
**LOCATION:** 785 Ridge Rd., Hamden, CT  
**PROJECT:** Perform Detailed Storm Drainage Piping Inspection / Cleaning  
**TECHNICIANS:** Calvin Anderson & Horace Hill

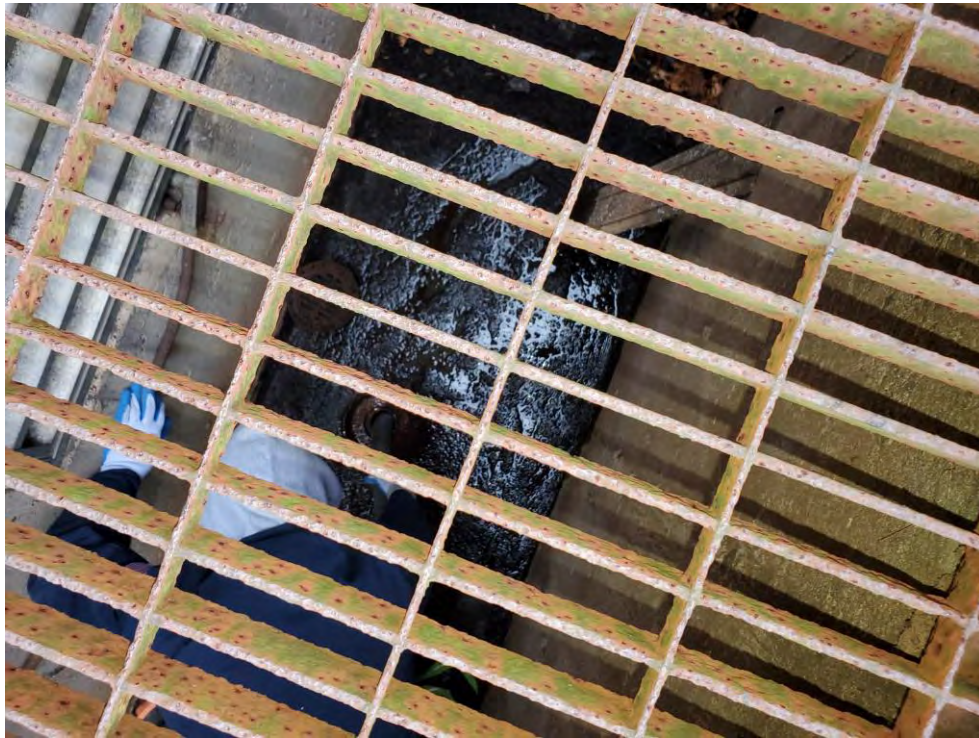
- Crew began investigation with outside Drain #1 which is located near the north vents outside of the basement mechanical room.
- Drain #1 was clogged and there was water infiltration into the basement mechanical room during heavy rain events.
- The drain required heavy cleaning and took several hours on cleaning attempts to finally clear.

**Photo from Drain Inlet #1 Before Clearing**

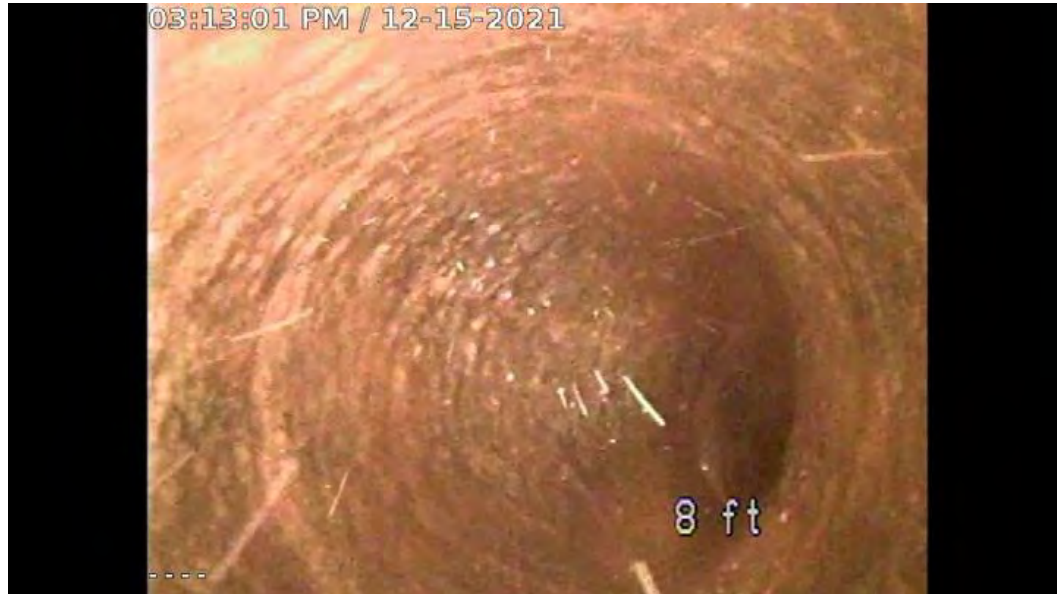
**Photo from Drain Inlet #1 After Clearing**

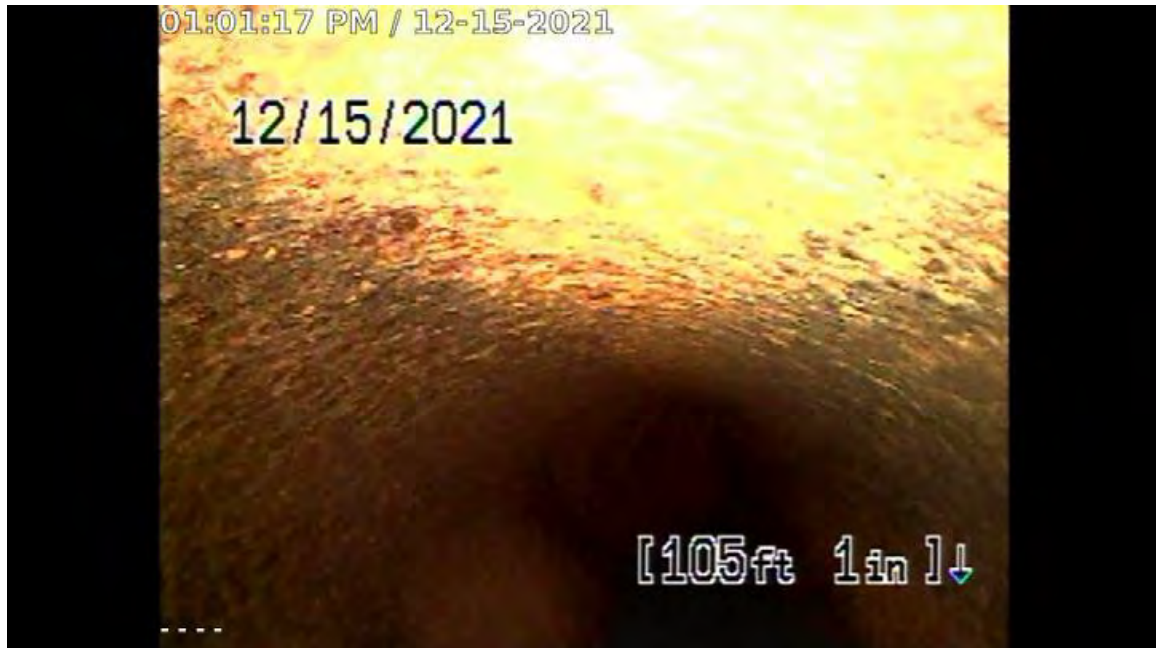
- Crew also inspected a roof drain storm stack Drain #2 in the basement mechanical room that is suspected connect to Drain #1 and drain inlet #3 (A 4" Clean out in the basement mechanical room).

**Photo from Drain #2 ( No Defects Observed)**

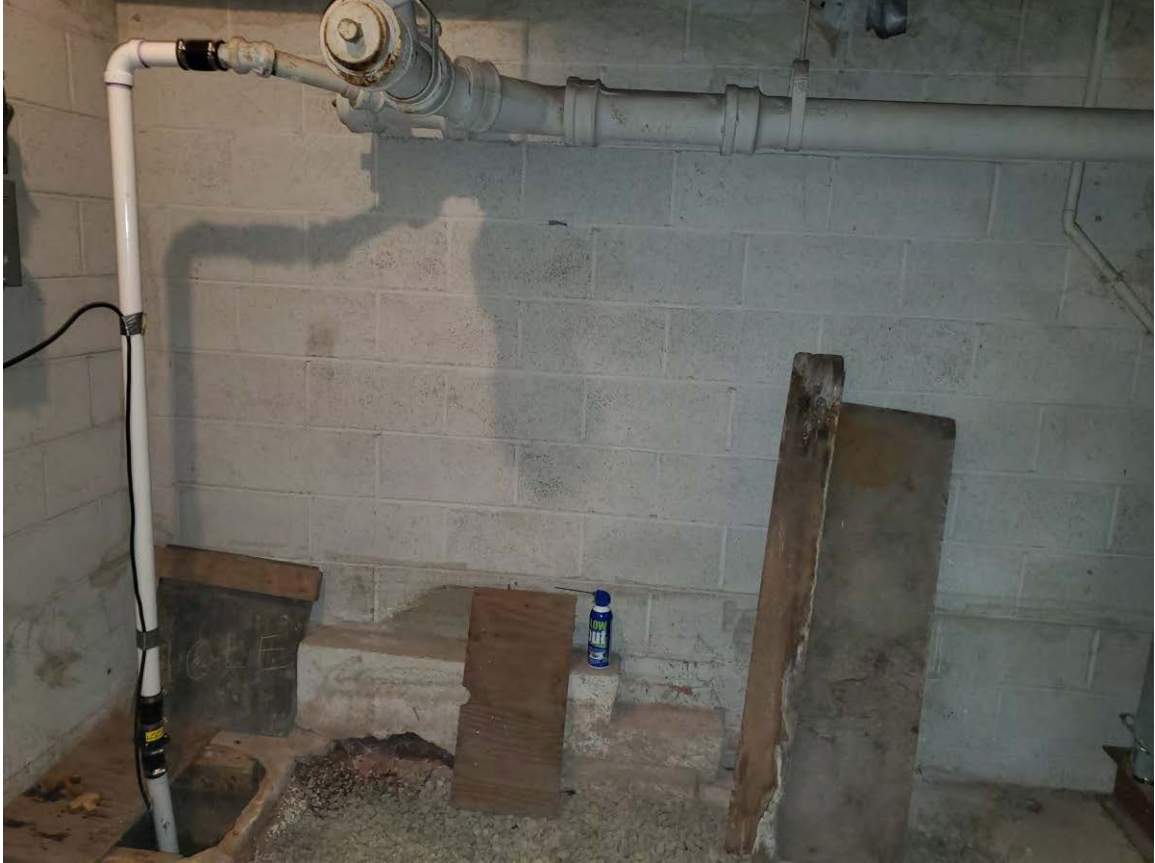
- Crew tested and confirmed that the existing sump pump in the basement is broken and the cause for the flooding in the front entrance basement area.
- It was recommended that the sump pump be replaced immediately.

**Photo from Broken Sump pump pit in Basement near Front Entrance**

- A working and reliable sump pump is recommended to avoid excessive flooding in this area because the pump sends all of the water from Drain #4 into the storm outgoing pipe toward the main.
