# NOTES & OBSERVATIONS

**CLIENT:** Walter Sedovic Architects    **Work Order** 1559    **DATE:** 12/28/21  
**LOCATION:** 785 Ridge Rd., Hamden, CT  
**PROJECT:** Perform Detailed Storm Drainage Piping Inspection / Cleaning  
**TECHNICIANS:** Calvin Anderson & Horace Hill

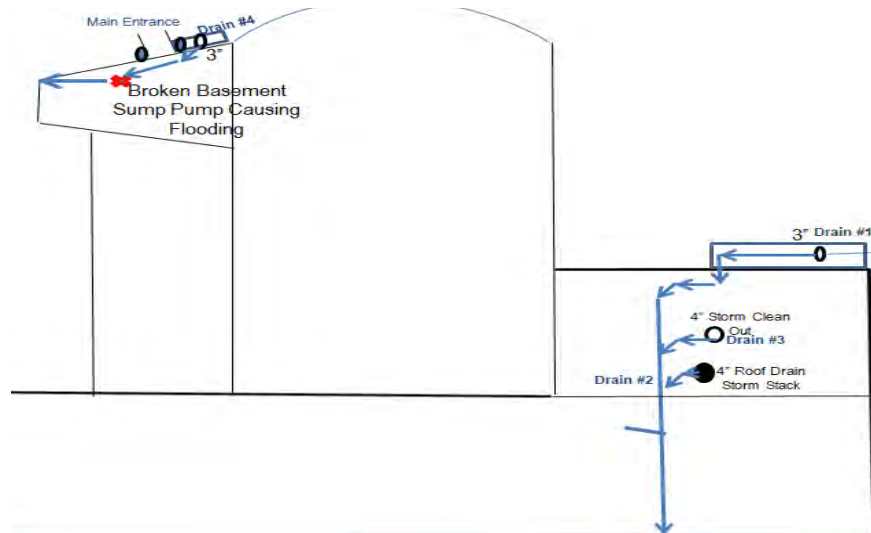
**Photo from Sketch of Congregation Mishkan Israel**

- On December 15, 2021, MES crew mobilized to assist Congregation Mishkan Israel facility with evaluating the existing condition of the storm roof drainage system causing water infiltration.
- The drain inlets involved with the investigation were numbered in the field (See MES Field Sketch)
- A portable, high resolution color camera was used to perform an internal inspection of the drainage piping
